ORCAS ISLAND FOUNDATION

FACILITIES AND INFRASTRUCTURE

FIVE YEAR CAPITAL PLAN 2026-2030

Prepared By: Facilities & Infrastructure Committee
Date: March 9, 2026

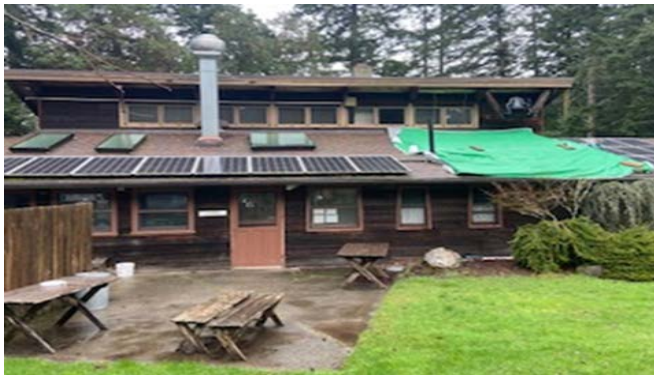
The last 3 winters have exposed the Dining Hall to high rainfall that has led to significant leaks in the roofing over the kitchen, toilets and office.

The resulting roof leaks have damaged the cubby space above the office, the office walls, the restrooms and kitchen roofing. The damage is not only to the roof’s asphalt tiles, but to the underlayment (plywood) and insulation (where it exists) as well as ceiling and walls of the Office and restrooms.

The existing asphalt tiles, underlayment and plywood need to be removed and replaced with metal roofing. Also because of the extensive damage from water leaks, the ceilings of the restrooms and office probably will have to be removed and replaced.

This portion of the roof needs to be replaced, preferably with metal (steel) Standing Seam (snap lock) roofing as soon as possible. This type of roofing is the most weather tight of metal roofing and require less maintenance and is appropriate for camp’s type of weather conditions.

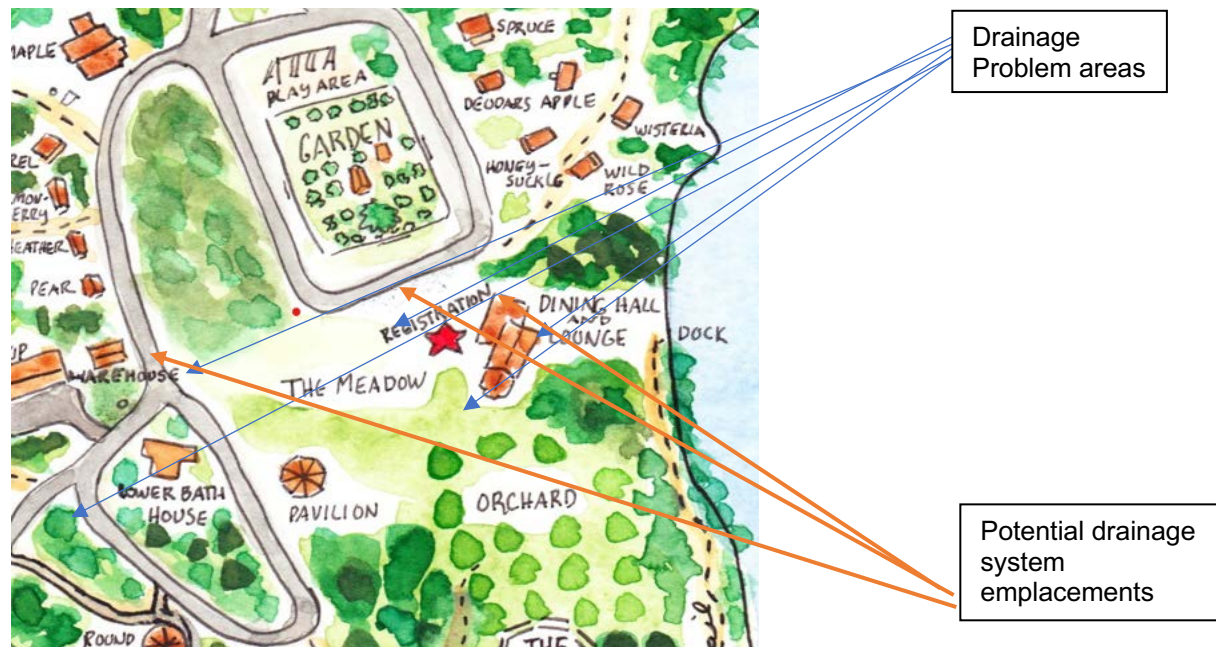
The meadow slopes from the RMC to the orchard and rainwater runs downhill alongside the roads as well as throughout the meadow. Basically, all the water runoff ends up at the Dining Hall Building and the volleyball court (and from there to the Lower Bathhouse and finally Juniper and Roundhouse).

The existing enclosed pipe drainage system along the wall of the lower garden has malfunctioned and added to the massive streams of water moving towards the Dining Hall. This leakage seems to have been going on for years and, apart from creating a muddy road, has flooded the basement a number of times.

Over the last couple of winters, the increasingly heavy “barrage” of rain during winter has been disastrous for Camp Indralaya. The basements have been flooded a number of times damaging food resources and the roof covering the kitchen and restrooms/office area has had numerous leaks. (see Appendix A, Exhibit 1)

It is essential to develop a more comprehensive drainage system that can handle the increasing extreme weather conditions.

- Assess existing system, develop drainage plan and develop scope of work
- Resurface and realign interior roads
- Develop drainage culverts on inner side of north and south loop roads and on the left-hand side of the center road
- Replace existing drainage pipe along lower garden wall with a larger one

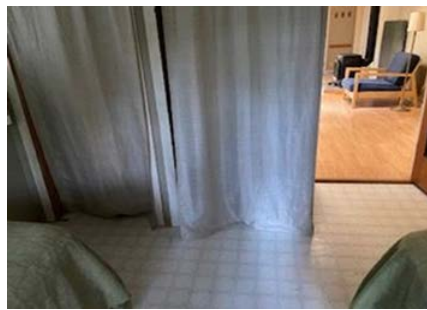
closet behind curtain

- Remove rough-in closet in Bedroom 1 and replace with chest of drawers
 - Remove closet in Bedroom 2 and use the existing wardrobe/armoire

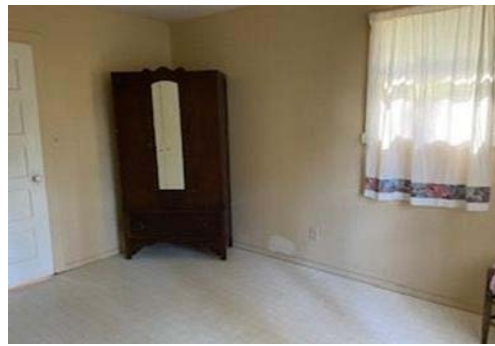
armoire

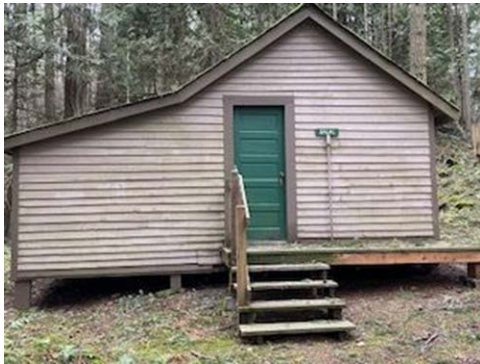
This cabin is in very poor condition - not suitable for occupancy. Constructed in 1934. It served as a "family cabin", with parents in the main room and children in bunk beds in the adjacent "lean-to". Unfortunately, this cabin has significantly deteriorated, post beetle and mold. This cabin needs to be demolished, a new design for a more comfortable and enlarged cabin developed.

This proposal requires demolition and a total redesign, even an expansion.

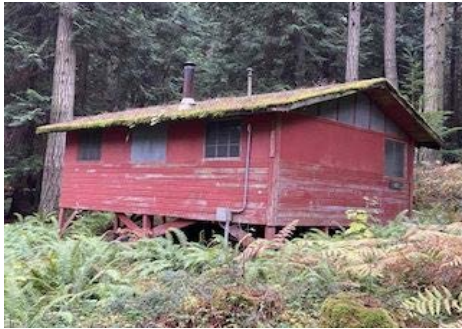
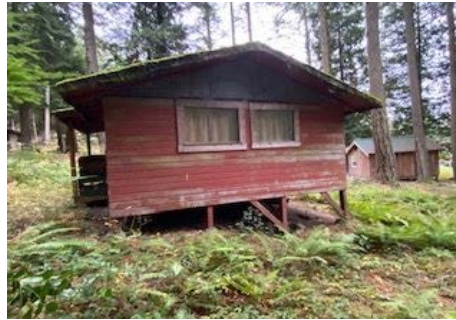
This cabin is in very poor condition - not suitable for occupancy. Constructed in 1952; remodeled in 2010. This cabin needs to be demolished, redesigned and rebuilt.

Plans and permits must be acquired before demolition.

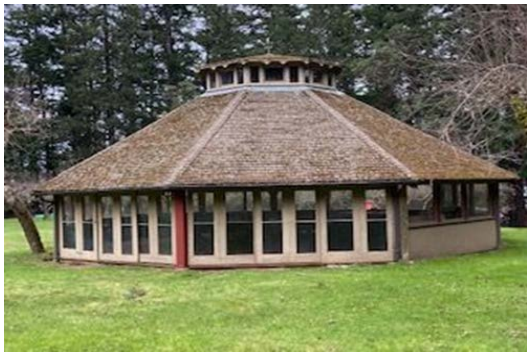
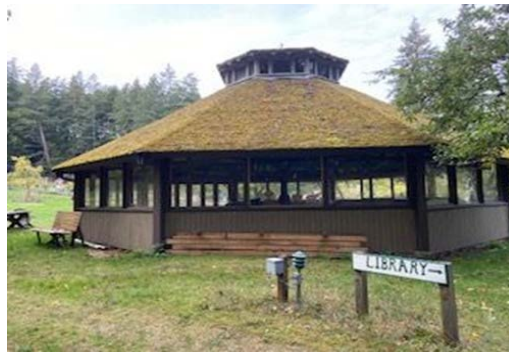
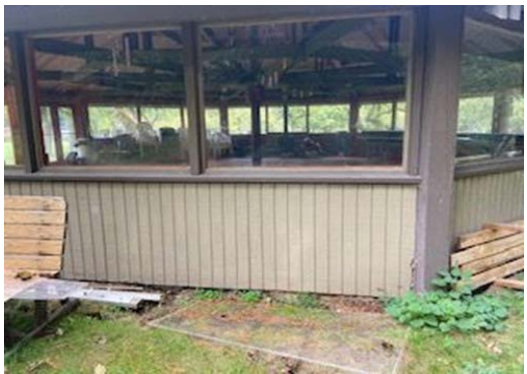
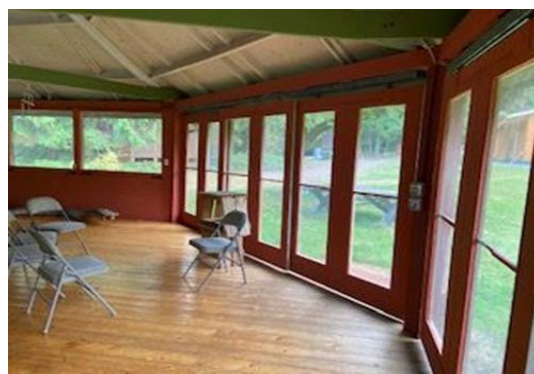
Project 6.B: Pavilion (Priority 3)

The Pavilion (formerly the Teepee) has been a gathering place from its first rendition. However, it has mostly been used in summer. With the increase in inclement weather and programs in both early Spring and late Fall, it has been frequently used as a gathering place for programs. Unfortunately, the facility was not designed for such activities. It is not designed for use outside the summer months.

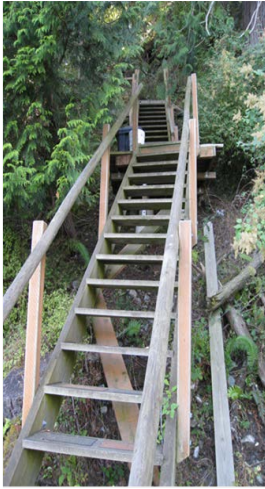
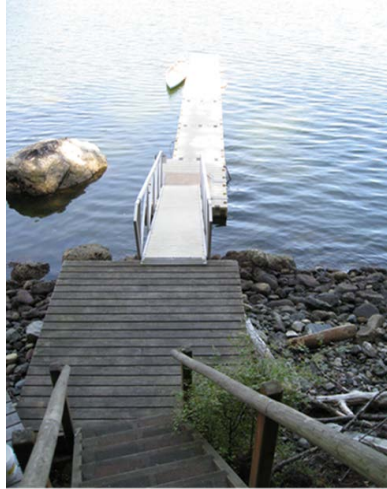
7.D Cove Dock (Priority 3)

Indralaya has a lease from DNR for our dock. In 2024, following a conversation with a DNR representative, it was established that our lease expired in 2011 but we are on a month-to-month lease (not unusual). We are in a “hold over” status. A lease for 4 years is \$60.88. Major repairs or significant changes cannot be done without DNR approval. Repairs (non significant) can proceed as long as they do not violate the terms of the current lease. When the new lease comes into effect (possibly in 2027? unknown...), we may be subject to new regulations though there would likely be a phase-in for these requirements.

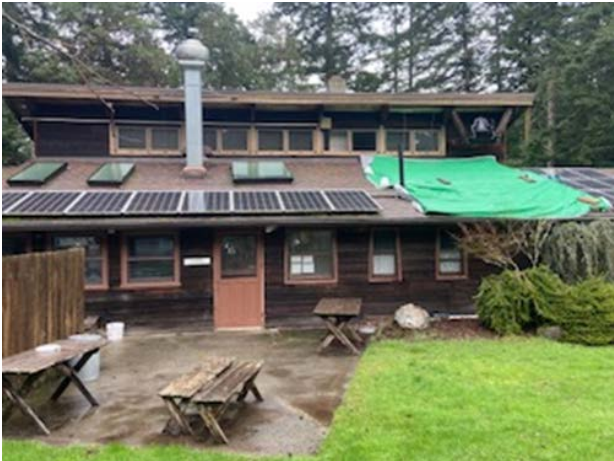
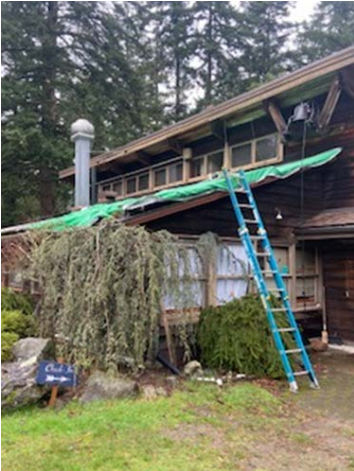
Roof damage and area to be replaced

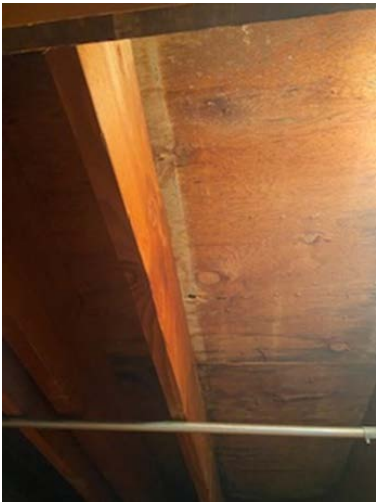
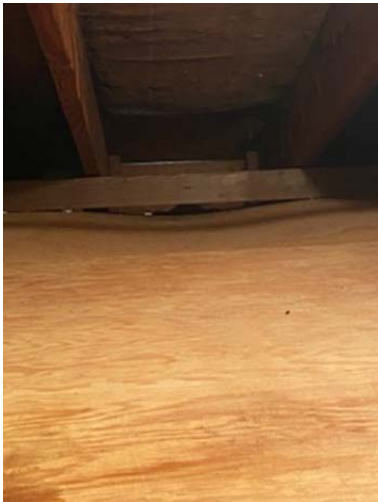
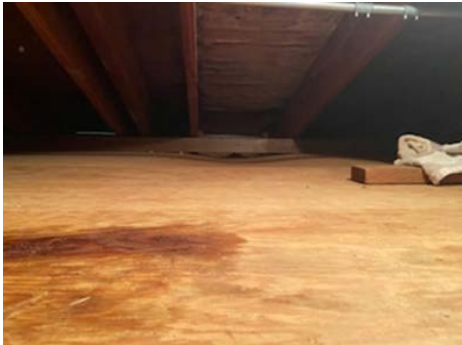
Dining Hall Cubby -damaged ceiling panels & damaged floor

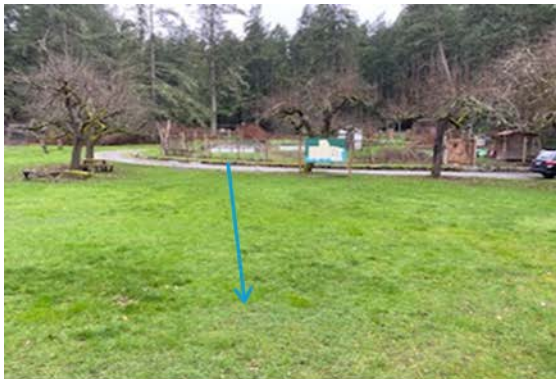
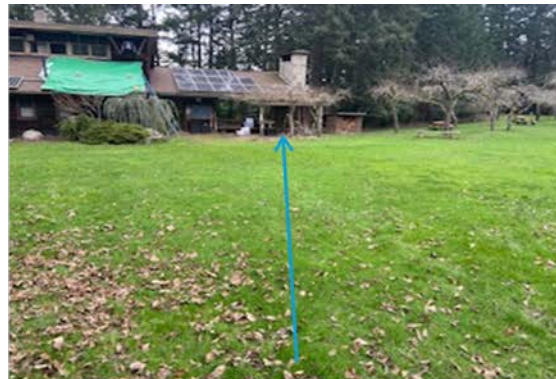
Where water goes from road

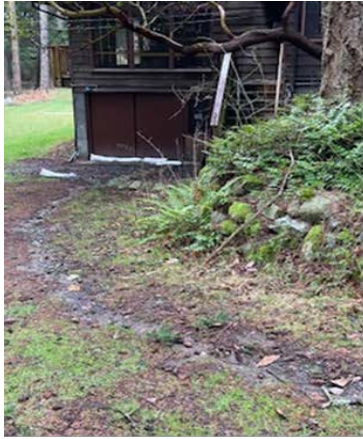
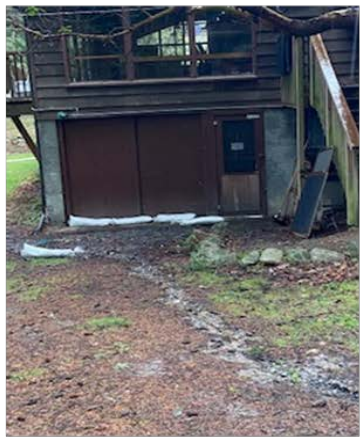
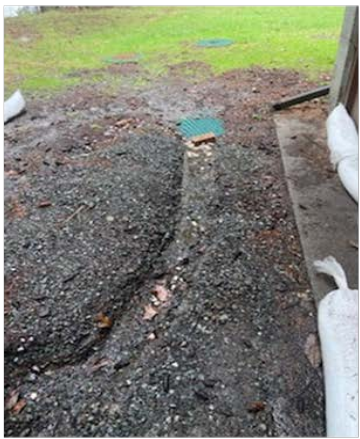
Right Loop Road

Top by RMC

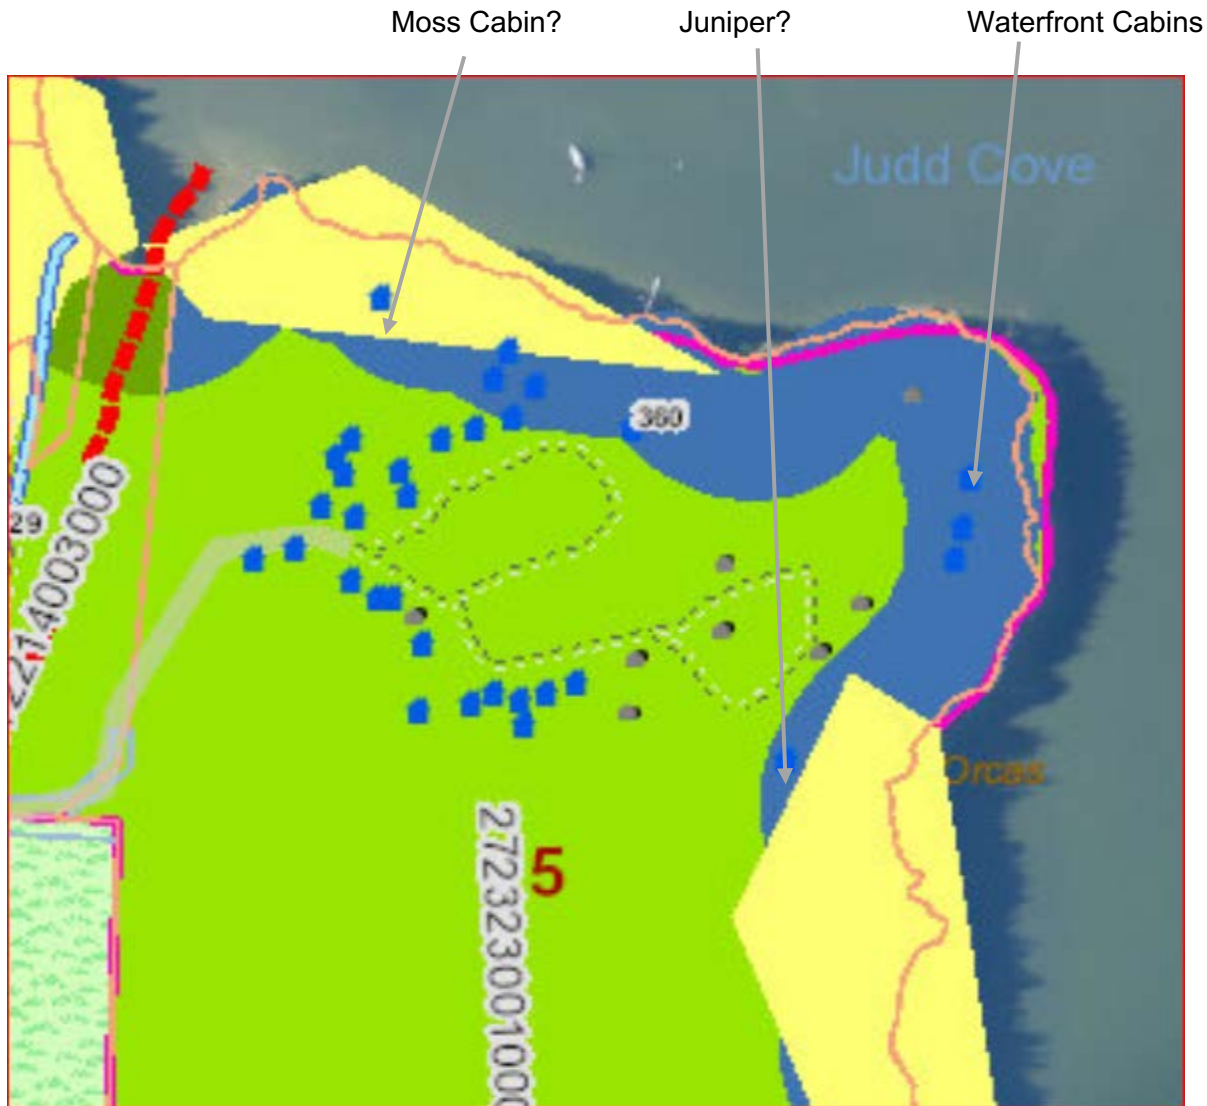
EXHIBIT 2 SAN JUAN COUNTY COMPREHENSIVE PLAN

This map shows the San Juan County's Comprehensive Plan and Shoreline Land Use designations, location of streams, and location of geological hazards on and near Indralaya. The green area on the map is the Rural Farm Forest designation. The blue band along the shoreline indicates the shoreline jurisdiction (200 feet from the ordinary high-water mark) and its designation as Conservancy. The yellow areas along the shoreline indicate slopes exceeding 15%. To the west of the camp is a stream (red dashed line).
